Manhole Inspection Summary

Manhole # S39S__037MH

Insp Date: **3/12/08 2:13 PM**

Location Address: **1403 jackson st**

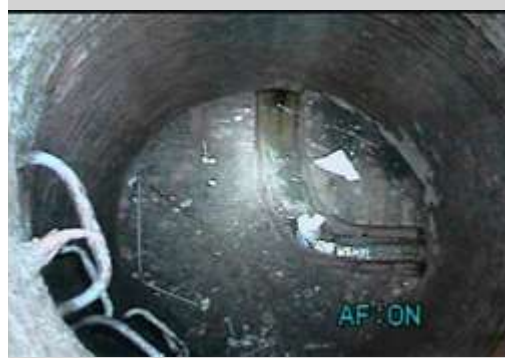
Top View

Frame Offset: **1** (in.) Condition: ☒ Sound ☐ Cracked ☐ Leaks

Condition: ☐ Sound ☐ Cracked ☐ Root Intrusion ☐ Loose Brick ☒ **Deteriorated**

Infiltration: ☐ None ☒ **Joint** ☐ Cracks ☐ Mortar ☐ Roots ☐ Wall
